Manhole Inspection Summary

Manhole # S39S__009MH

Insp Date: **3/12/08 10:31 AM**

Location Address: **1311 webster st** Cross Street: **key hwy/ unnamed alley**

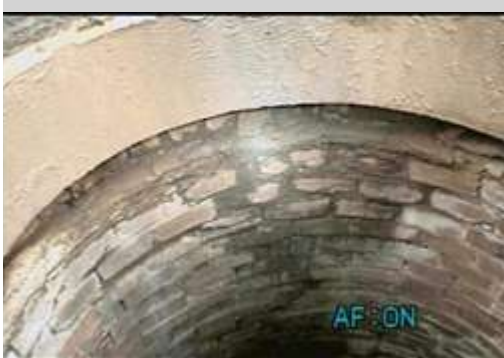
Defect 2

Condition: ☐ Sound ☐ Cracked ☐ Root Intrusion ☒ **Loose Brick** ☐ Deteriorated

chimney cond loose bricks, adjustment

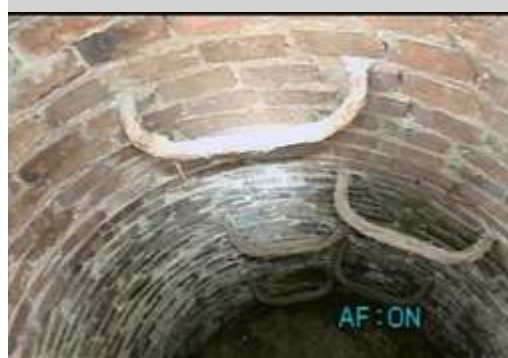
Defect 1

Steps Count: **5** Missing: **0** ☒ **Corroded**

corroded steps

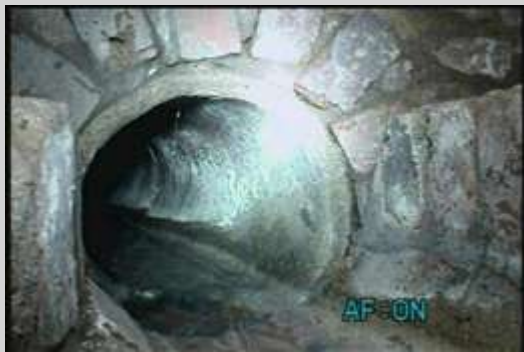
12 O'Clock Outflow

8 in. Circular Gravity Sewer
Pipe Out @ 12 O'Clock

Infiltration: **None** Pipe Seal Cond: **Unknown**

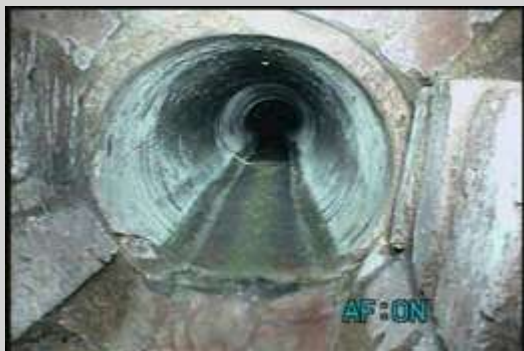
9 O'Clock Inflow

8 in. Circular Gravity Sewer
Pipe In @ 9 O'Clock

Infiltration: **None** Pipe Seal Cond: **Unknown**
